Acoustic emission monitoring of Italian historical buildings and the case study of the Athena temple in Syracuse

Giuseppe Lacidogna, Amedeo Manuello, Gianni Niccolini & Alberto Carpinteri

Keywords: acoustic emission; cracking evolution; damage localization; masonry constructions; structural assessment

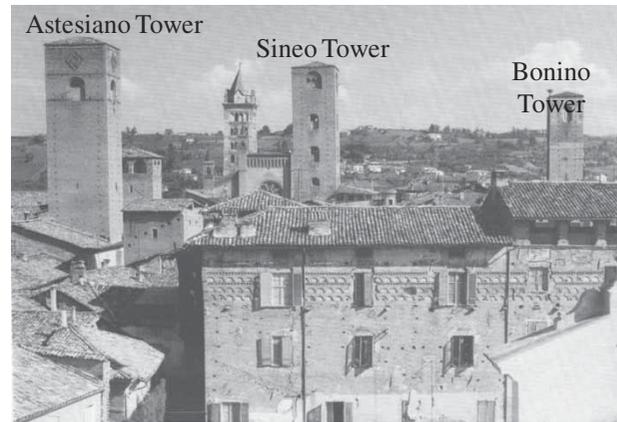
Figure 1. Astesiano, Sineo and Bonino Towers in the skyline of the City of Alba.

In particular, the medieval towers of Alba have been monitored by the AE technique. These masonry buildings from the XIIIth century are among the tallest and mightiest medieval towers preserved in Piedmont (Figure 1). Sineo Tower is square, 39 m high, and leans to a side by about 1%. Wall thickness ranges from 2 m at the foundation level to 0.8 m at the top. The bearing walls are a sacco, that is, consist of brick faces enclosing a mixture of rubble and bricks bonded with lime and mortar. Over a height of 15 m, the tower is incorporated in a later building. Astesiano Tower has a similar structure, but has a rectangular base. The total height is about 36 m and the tower does not lean on any side. Torre Bonino, just under 35 m high, is the least imposing of the towers analysed, but the square-shaped structure has been incorporated in a valuable building from the Italian Art Nouveau period.

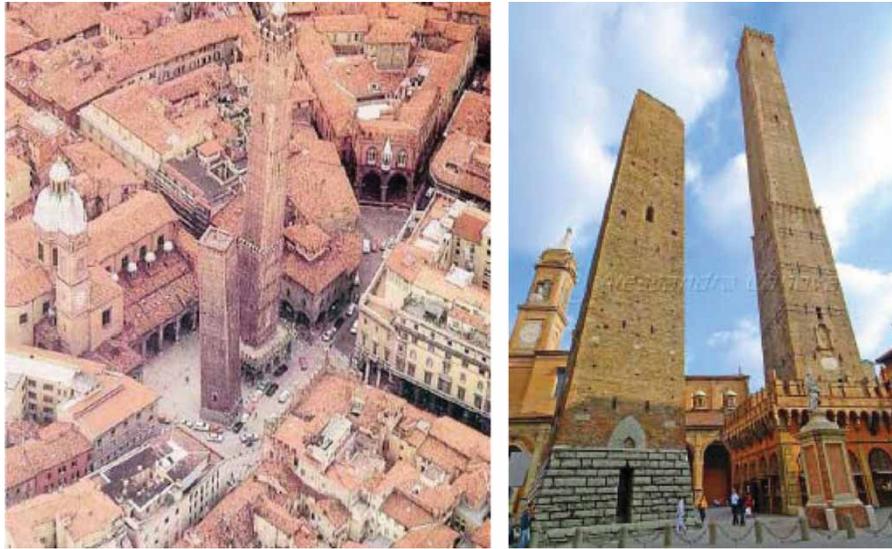
Figure 3. Photos of the Asinelli Tower and the Garisenda Tower in the city centre of Bologna.

The AE technique was also used to assess the structural stability of the Asinelli Tower, the tallest building in the city of Bologna (Italy), which, together with the nearby tower, named Garisenda, is the renowned symbol of the city (Figure 3) (Carpinteri *et al.* 2012). The Asinelli Tower was built in the early XIIth century, and it rises to a height of 97.30 m above the ground. It has a square cross-section, tapering along its height, the sides measuring ca 8.00 m at the base and 6.50 m at the top.
