# Acoustic Emission Monitoring of the Turin Cathedral Bell Tower: Foreshock and Aftershock Discrimination

**Featured Application:** The Acoustic Emission (AE) technique can be used to perform structural monitoring of historical buildings including tall masonry towers. In addition, the AE data detected on the structure, during the earthquake activity, can be used to discriminate foreshock and aftershock intervals.

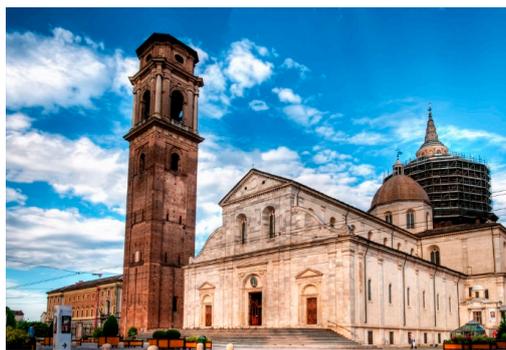
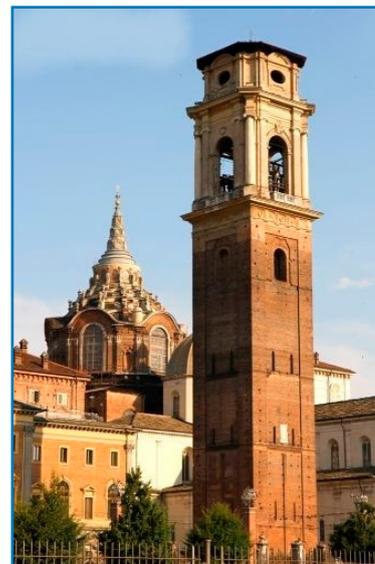
**Figure 1.** Architectural complex of the Cathedral with the bell tower in the front and the dome erected by G. Guarini: (a) on the backside; (b) view of the isolated bell tower from the other side

The bell tower was initially built in the second half of the 15th century between 1468 and 1470 [11,12]. Recently restored, the tower is inserted, today, in the Diocesan Museum of the Sabaudian city (see Figure 1). The masonry tower was erected completely by the will of bishop Giovanni di Compey (Figure 1a). Between 1720 and 1722, the court architect Filippo Juvarra worked on the crowning and the dome, the tower assumed its current appearance—a brick construction that ends with a baroque bell tower made by stone decorations [11,12] (see Figures 1b and 2).

Christian churches, still marked at the top by the opening of the ancient bell cell; and the 18th-century crowning—the unfinished realization of Filippo Juvarra’s project (Figure 2b). The ancient part is a square plan of about 10 meters ( $9.70 \times 9.70$ ) on each side with perimeter walls of a constant thickness (2 m) up to the Juvarrian crown, where, in correspondence to the bell cell, the square is connected to an octagon. The restorations of the 1980s were followed up in 2013 by the architects Maurizio and Chiara Momo. In the last few years, the bell tower was subjected to the last external restoration works that completely returned the tower to the city in all its magnificence (Figure 1b).

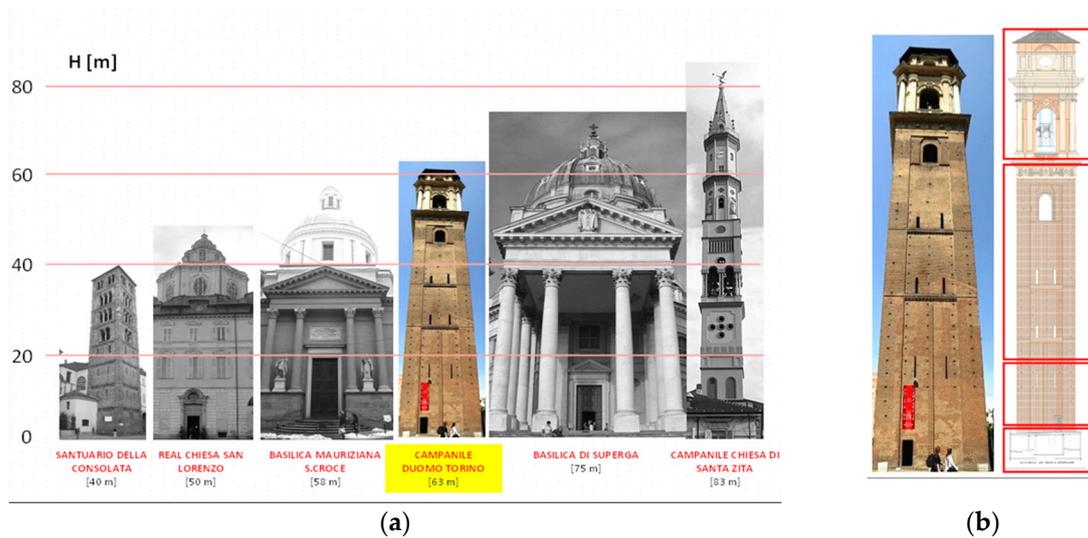
**Figure 2.** Tall masonry building in Turin and parts constituting the bell tower. (a) The bell tower is the third tallest masonry building in the city (63 m); (b) The tower is subdivided into different parts—the stem and the bell cell are constituted by different materials and were erected in different times and by different building techniques.

The bell tower is today the third tallest masonry building in the City, (63 m) (see Figure 2a). As mentioned, the structure, finished around 1470, was built next to the paleochristian complex of the so-called three churches, the communicating buildings of San Salvatore, Santa Maria, and San Giovanni Battista. Successively, the structure was incorporated into the building of San Giovanni. About 20 years later, the churches were destroyed, and in their place, the city's cathedral was built. The brilliant architect Meo del Caprina designed the cathedral, and the original tower became the bell tower, connected to the church by an underground gallery that is now part of the Diocesan Museum (Figure 1a). The tower was restored for the first time in 1620, and a century after, the design of Filippo Juvarra was completed for the top cell and the roof. When the Palazzo Vecchio was demolished in the 19th century, the bell tower remained isolated and ignored until 1986, when contemporary restorations were started by the architects Maurizio and Giuseppe Momo. The tower, therefore, consists of two distinct parts: the 15th-century tower, with a squared plan erected on the site of the early

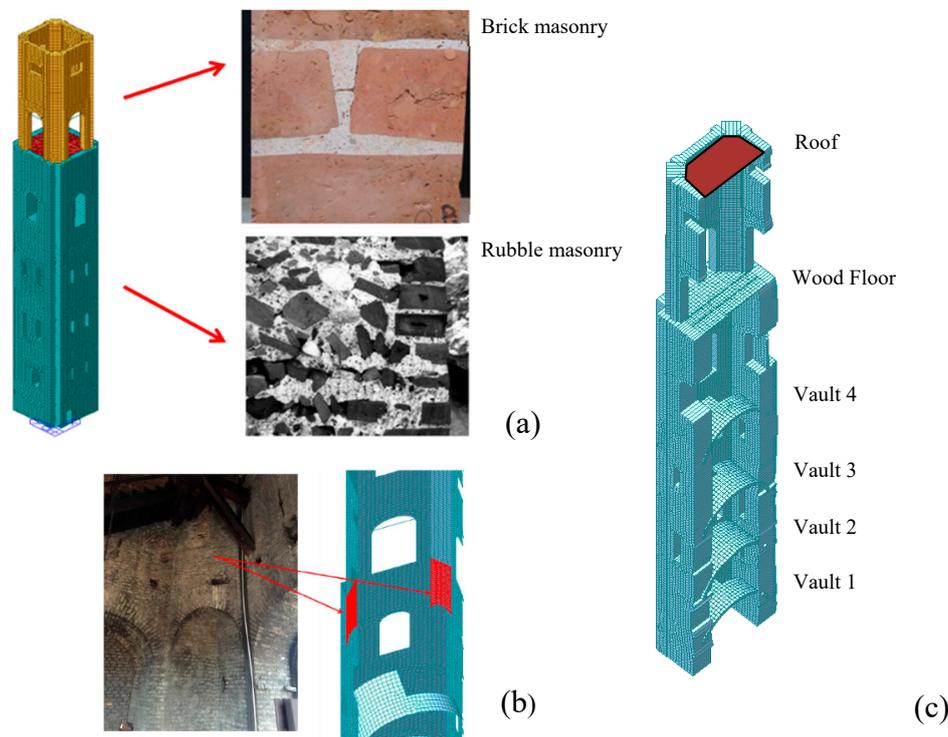
**Figure 3.** The FEM: (a) The bell tower is made with different materials and different building techniques (sack masonry). (b) Chains have also been inserted within the model in correspondence with the “key heads” observable from the outside. The loads of the various elements were assessed by multiplying their thickness by the specific weight of the materials. The different dead loads were associated to the different levels and structural elements. (c) Axonometric cross-section of the tower.

Starting from the results of the survey, FEM was implemented with the aid of Midas FX software (CSP Fea Engineering, Padova, Italy), a three-dimensional geometric modeler completed by the FEM modulus. Through the CAD (computer-aided drafting) reproduction, the geometric model of the tower was initially defined, from which, thanks to the software's auto-meshing function, the FEM model was obtained. In Figure 3, the model obtained is shown.

In addition, thin elements have been inserted (chain) (see Figure 3b), which act as connections between the two different parts of the tower—the stem and the cell. In this way, the loads of the bell cell are gradually transferred on the fifteenth-century part of the tower. Chains have also been inserted in the model in correspondence with the “key heads” observable from the outside; the external ‘keys’ and the inserted chains can be seen in Figure 3b. It can be observed that some chains do not circumscribe the tower; this is due to the fact that they have only been inserted in correspondence with the externally visible “keys.” This operation is therefore in favor of safety, since the chains are certainly less in number than those actually present in the structure.

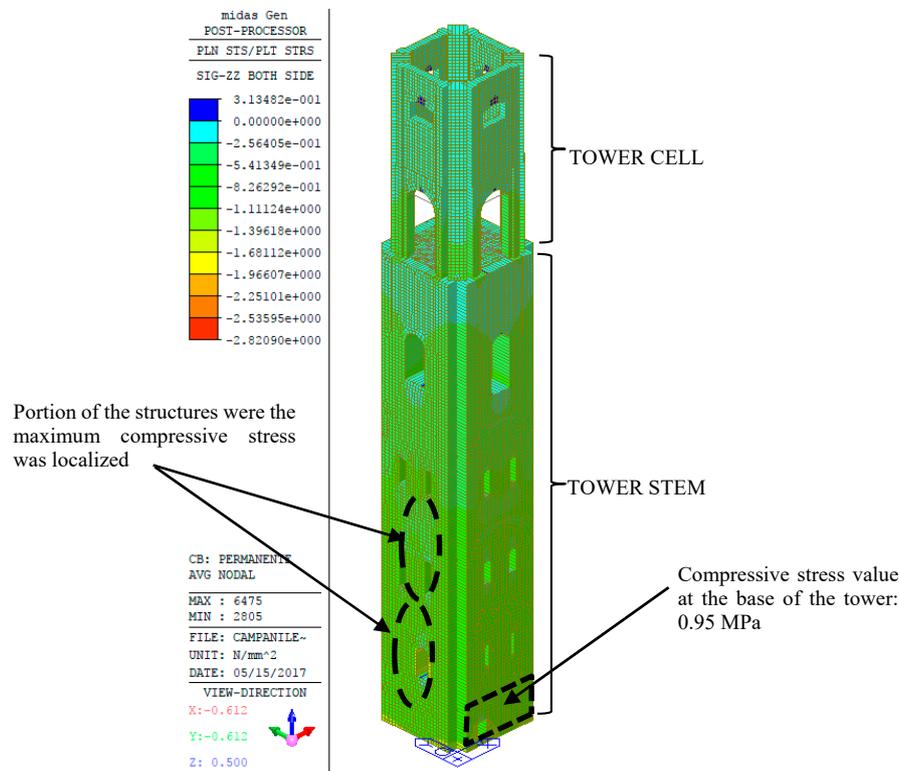
**Figure 5.** Portion of the structures were the maximum compressive stress was localized. The compressive stress value at the base of the tower is 0.95 MPa.

The results of the static analysis are reported in Figure 5. The value of the compressive stress, as reported previously, was equal to 0.95 MPa at the base of the tower. On the other hand, in a localized portion of the structure, related to the opening disposition, the compressive stress reached higher values up to 1.4 MPa. These values were observed particularly on the south façade of the tower, between the second and the third level.

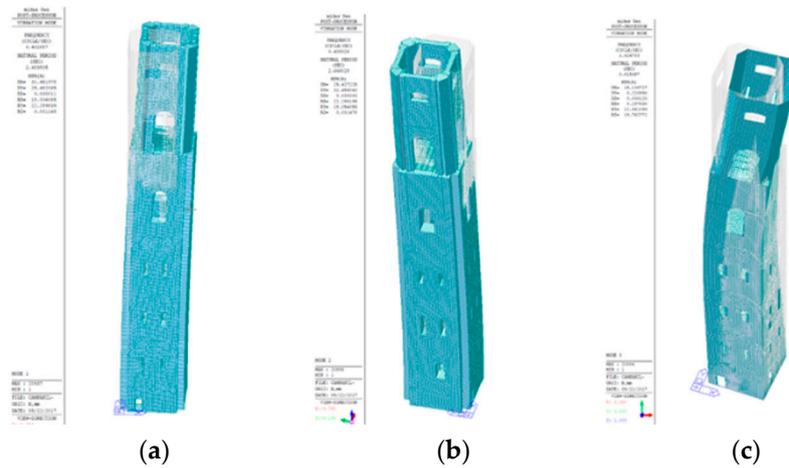
**Figure 6.** Representation of the modal analysis: (a,b) The two modes of the tower in the y and the x directions, represented by flexural modalities, (c) The third mode showing a torsional modality.

In order to further validate the numerical model, the results of the modal analysis are shown in Figure 6, and the first three vibrating modes were investigated and reported. It can be observed that the first and second modes are flexional, characterized mainly by displacements in x and y directions, while the third is torsional. In Tables 4 and 5, the results of eigenvalue analysis and the masses participating in the individual modes were reported. In the last table, the values of the predominant masses of the

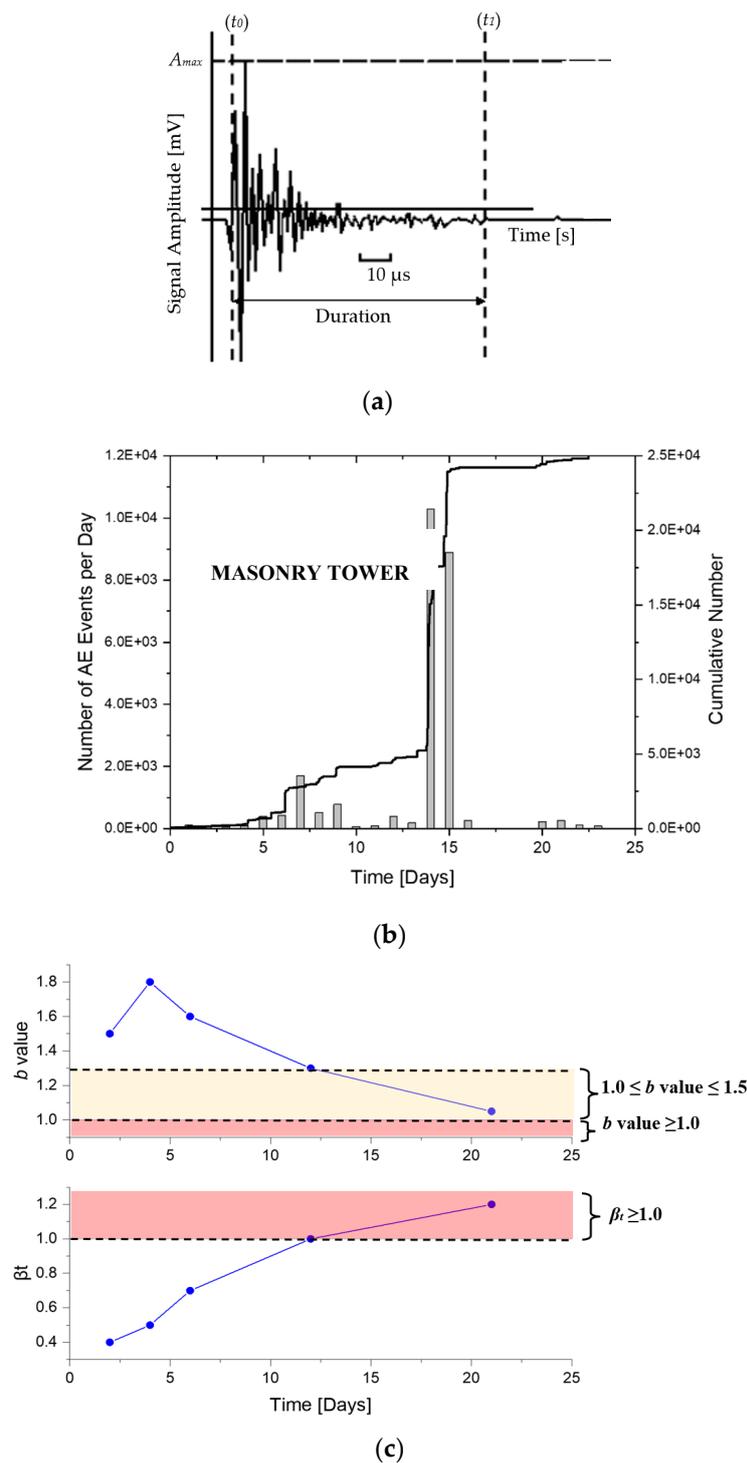
**Figure 7.** AE signal and AE results of the tower: (a) Typical received signal in the time domain during the acoustic emission (AE) monitoring. The AE equipment used in the present paper allow to set the appropriate threshold value due to the monitored structure and the environmental conditions. (b) Cumulative number of AE and AE count per day during the monitoring time. (c)  $b$ -value diagram representing the evolution of the damage,  $\beta_t$  trend evolution during time.

The analysis of the  $b$ -value has been widely used for the application of AE analysis. In particular, during the last few decades, very important results were achieved for concrete structures using  $b$ -value and improved  $b$ -value by Shiotani et al. [27,28]. In present paper, in order to carry out an accurate study, the disturbances of the environment and the noise filters of the instrumentation have been optimized. In particular, a filtering on amplitude signal levels and frequency values is adopted for the AE time series. The  $b$ -value trend was obtained working on time windows containing at least 100 AE. Signals with repetitive frequency values or too far from the typical range proper of the frequency of the damage source generation in these types of materials have been discarded. In particular, it is interesting to note that the  $b$ -value showed a decreasing trend that is compatible with the growth of macro-cracks localized in the south side of the tower between the second and the third level, in correspondence of the portion of the monitored structure. After 12 monitoring days, the  $b$ -value trend entered the  $1.5 < b\text{-value} > 1.0$  phase, corresponding to a critical condition (Figure 7c).

In this phase, the localized point started to be found by the triangulation procedure as stated in the following. After 21 monitoring days, the trend approached the local collapse condition  $1.0 < b\text{-value}$  (Figure 7c). This phase was correlated with the intensification of the localized point of the damage sources (Figure 8), in correspondence of the evolution of active cracks (Figure 8a,b). Furthermore, as reported in Figure 7c, the growth of the  $\beta_t$  toward values higher than 1.0 in correspondence with the decrease in the  $b$ -value highlighted the instability of the crack growth process. As mentioned before, the localization procedure was employed to evaluate the source damage position and the diffusion of the cracking pattern. Localization is one of the most used analysis in AE monitoring. The AE localization technique has been widely applied in laboratory and in situ tests, as well as, has been performed with different methods in order to improve the results accuracy [29–41]. In this second stage (low  $b$ -value and higher  $\beta_t$ ) in fact, the formation of micro-cracks in a 3D space is analyzed, and the triangulation technique was applied to signals recorded by at least five sensors falling into time intervals sufficiently small ( $50 \mu\text{s}$ ). Thus, with this procedure, it is possible to define both the position of the micro-cracks in

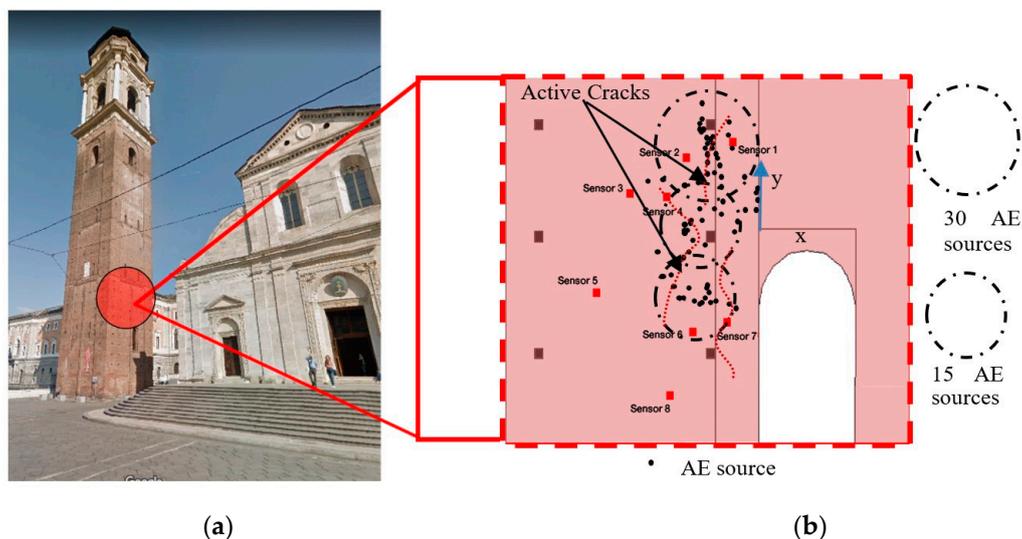
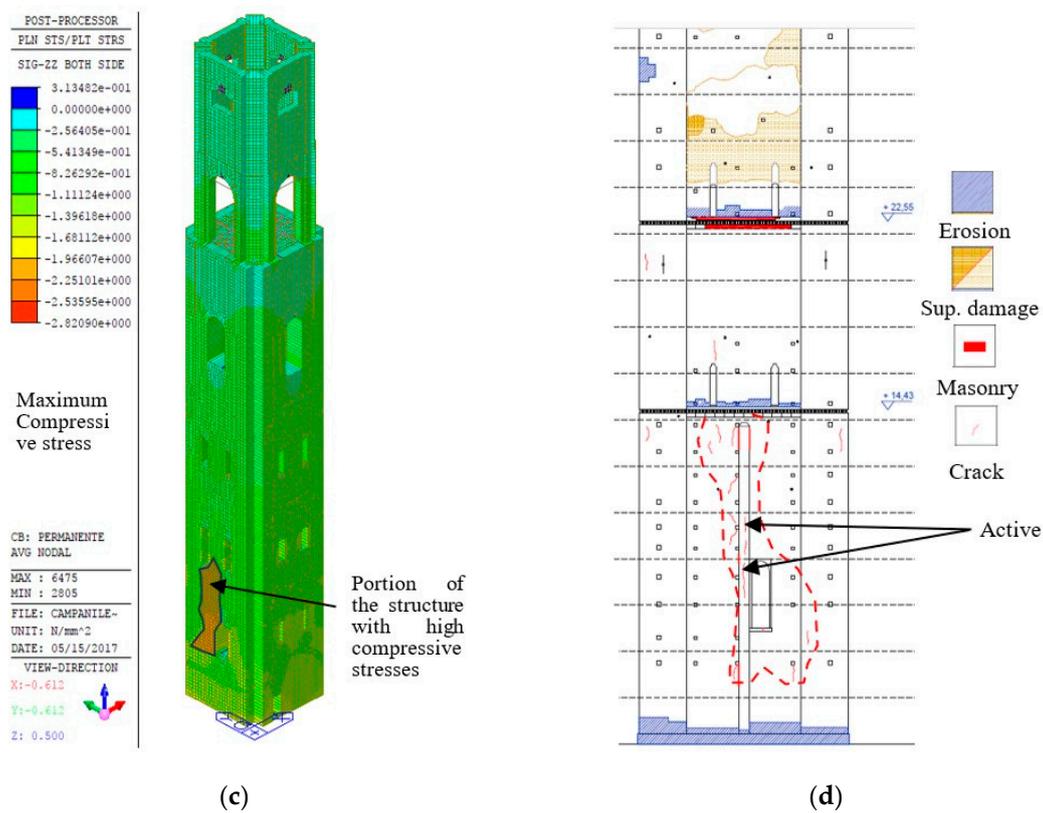
**Figure 8.** AE localization results. In (a), the portion of the masonry structure where the AE sensors were positioned. The localized points have been indicated with black points, for a total of 62 AE sources (b). Three circles are reported in correspondence to the center of AE source clusters. Two levels of cluster are reported with circle radius proportional to the number of AE source inside the areas. (c) The results of the numerical analysis reported the portion of the structure with higher compressive stress. (d) The same area is reported considering the crack position the erosion areas and the damaged surfaces.

the distance between  $S_i$  and source  $S$ , in Cartesian coordinates, and assuming the material to be homogenous, the path of the signal is given by  $|S - S_i| = v(t_i - t_0)$ . If the same event is observed from another sensor  $S_j$  at time  $t_j$ :  $|S - S_j| - |S - S_i| = v(t_i - t_0)$ . Assuming the arrival times of the signals and the positions of the two sensors to be known, the last is an equation with four unknowns— $x$ ,  $y$ ,  $z$ , and  $v$ . Hence, the problem of the localization of  $S$  is determined if it is possible to write a sufficient number of equations of that type, i.e., when the same AE event is identified by at least five sensors. If this did not occur, it would be necessary to adopt simplifying assumptions to reduce the degrees of freedom of the problem, such as, for instance, imposing the speed of transmission of the signals or having the AE source lie on predetermined plane. For the analysis carried out in the present research, three-dimensional localizations with at least five sensors were performed. In particular, Figure 8a and Table 6 indicate the position where the sensors were applied, (Figure 8b) the result of the localization with the source points projected on the surface of the facade, (Figure 8c) the relationship with the main results of the numerical model, and (Figure 8d) the detection of damage together with the crack pattern on the same portion of the structure. The localization procedure is based on the principles recently reported by the same authors concerning the signal accuracy [20]. Finally, according to the steps described in the previous section, the sources of AE events were localized. The localized points have been indicated with black points, for a total of 62 AE sources. In the figure, three circles are reported in correspondence to the center of the AE source clusters. Two levels of cluster are reported with circle radii proportional to the number of AE source inside the areas (see Figure 8b). In Figure 8d, the map of surface erosions, masonry gaps, surface damage, and cracks was reported. The AE localization allowed us to identify the portions of the masonry where active and growing cracks were concentrated (Figure 8b). These areas are also those where the highest values in compressive stresses were observed through the numerical model during the static calculus (Figure 8c).

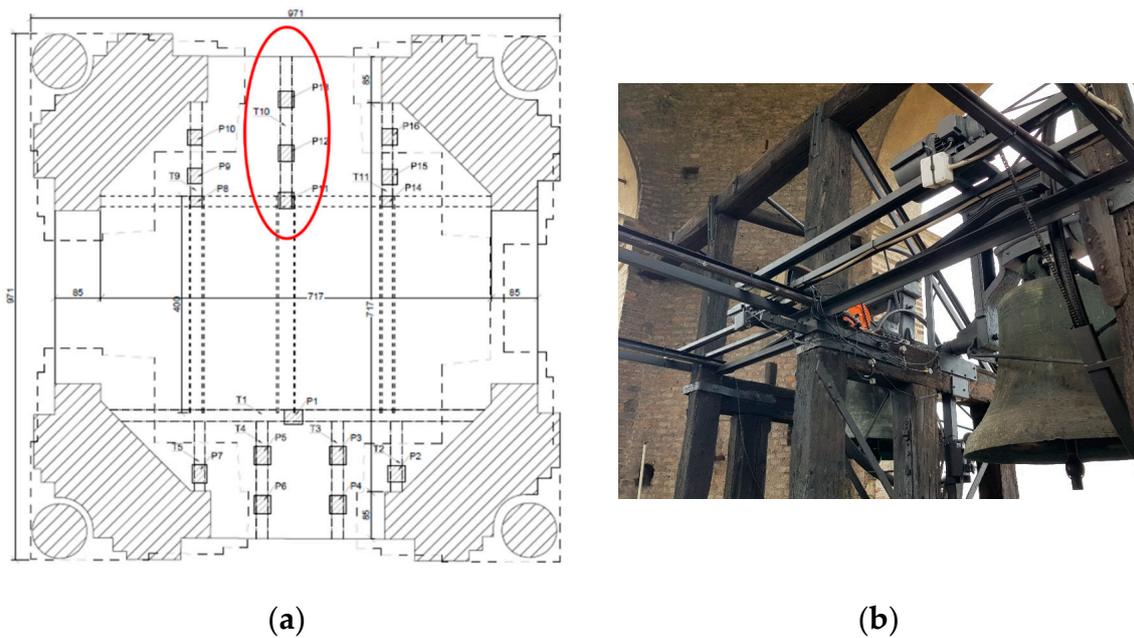
**Figure 9.** Timber structure positioned inside the bell cell at the top of the tower: (a) Plan of the cell where the timber frame layout is reported. The monitored portion is localized. (b) AE sensors disposition on the wood frame.

The second part of the Bell Tower subjected to the AE monitoring is the timber structure sustaining the bells, positioned inside the bell cell at the top of the tower (see Figure 9). In this case, the wooden structure supporting the bells was monitored with an eight-channel acoustic emission data acquisition system to evaluate the evolution of the cracking pattern evolution over the monitoring time (see Table 7 for the sensor positioning). The sensors were positioned in the wood frame sustaining the heaviest bells, as shown in Figure 8. The structure was monitored for a period of time equal to one month; in particular, the monitoring was carried out from 8 August to 8 September 2019.

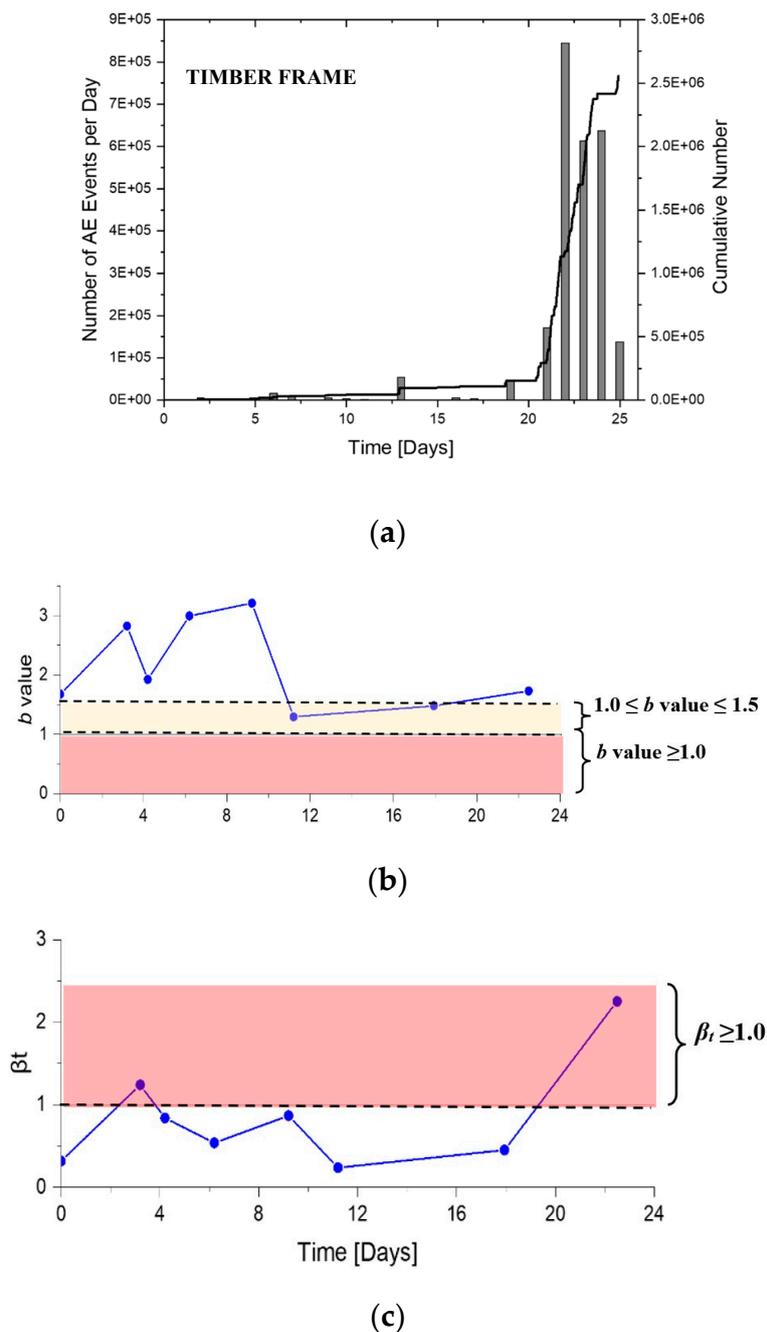
**Figure 10.** Timber frame of the cell: (a) Cumulative number of AE and AE count per day during the monitoring time. (b)  $b$ -value diagram representing the evolution of the damage. (c)  $\beta_t$  trend evolution.

The analysis of the data extracted from the AE device followed similar steps previously observed for the monitoring of the masonry structure of the Bell Tower (see Figure 10). Figure 10a shows the AE cumulative number recorded during the monitoring period and the number of EA events for each day for the timber frame. The  $b$ -value trend was obtained working on time windows containing at least 100 AE. As observed in the case of the masonry structure, the  $b$ -value assumed numbers greater than 1.5, in correspondence with the first monitoring phase (first 10 monitoring days). After 11 days, the analysis results entered the critical band  $1.5 > b\text{-value} > 1.0$  (Figure 10b). In addition, as seen in Figure 10c, the  $\beta_t$  exponent showed an evident growth after 17 monitoring days. This increment is not perfectly correlated with the  $b$ -value decrease, but the two phases can be considered just in correspondence.

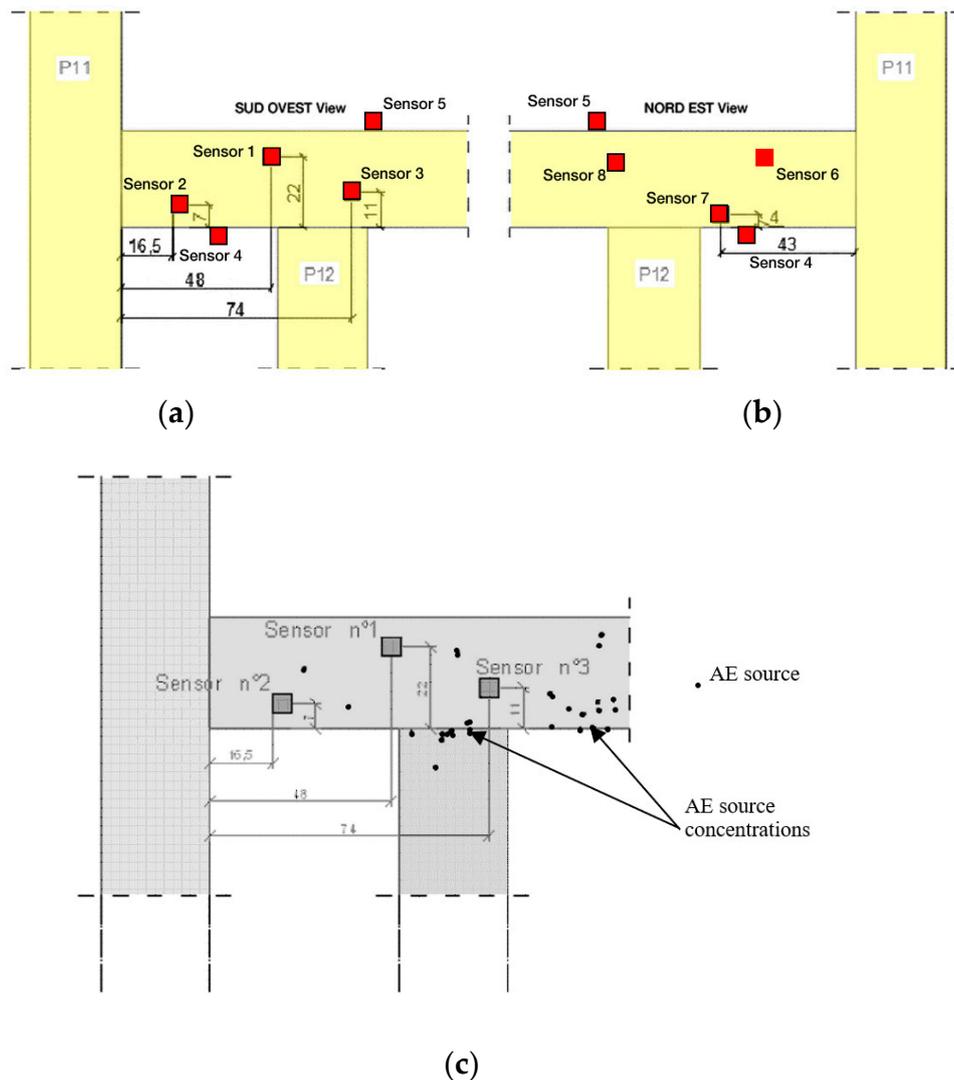
**Figure 11.** AE localization results. In figure (a) and (b), the portion of the wooden frame where the AE sensors were positioned is showed, (c) The localized points have been indicated with black points, for a total of 24 AE sources.

Finally, the sources of AE events were localized. The position of the sensors and the localized sources are shown in Figure 11a,b. The localized points have been indicated with black points, for a total of 24 AE sources. In this Figure, two circles are reported in correspondence to the barycenter of AE source clusters. Two levels of cluster are reported with circle radii proportional to the number of AE source inside the areas. The results of the AE localization, together with the  $b$ -value trend, made it possible to identify the column-beam joint and the portion of the beam close to the pin of the big bell as a portion of the wood frame affected by crack formation and damage growth.

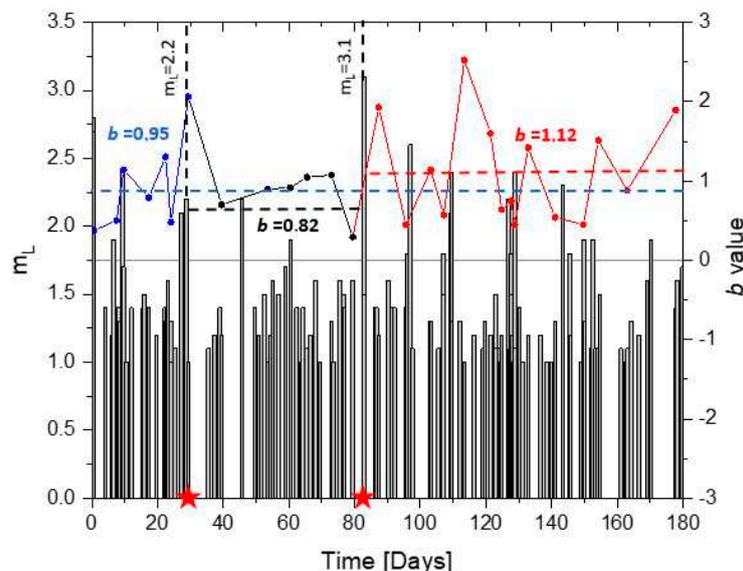
**Figure 12.** The average  $b$ -values before the “anticipator” event (12 April 2018) is equal to 0.95. After this, an evident reduction in the average value equal to 15% is observed (average  $b$ -value = 0.82). The main event occurred about 50 days after (5 June 2018). After the  $m_L$ : 3.1, no event with greater magnitude were registered for three months.

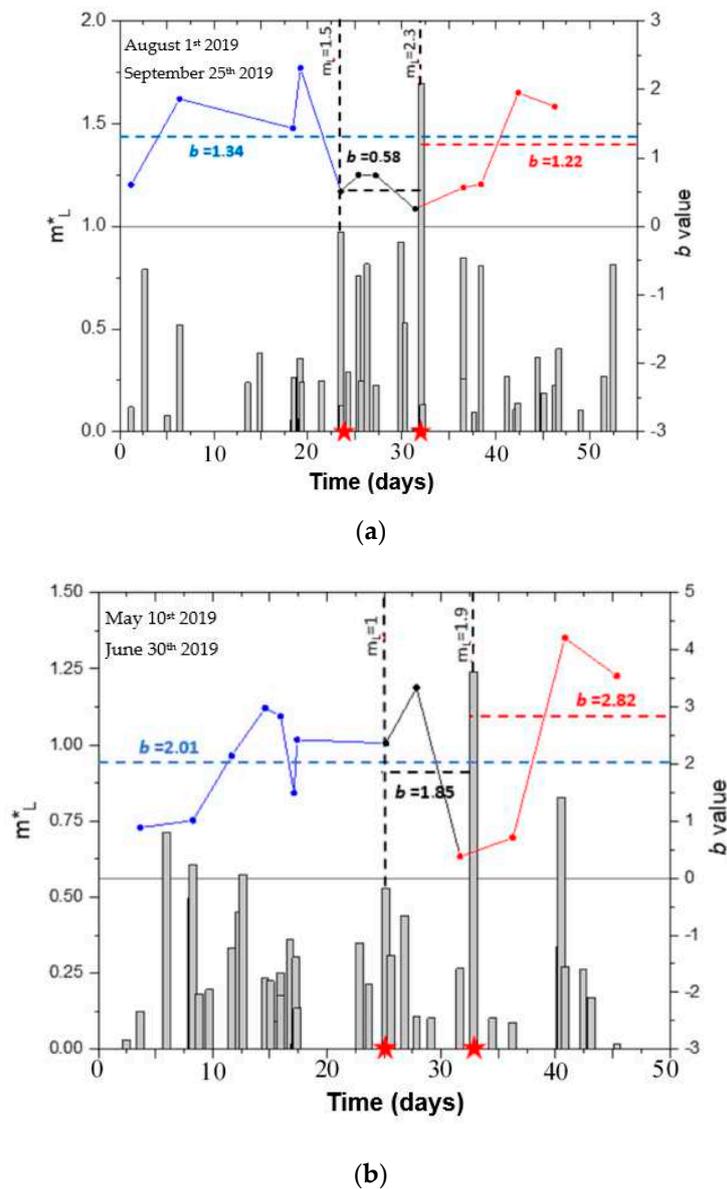
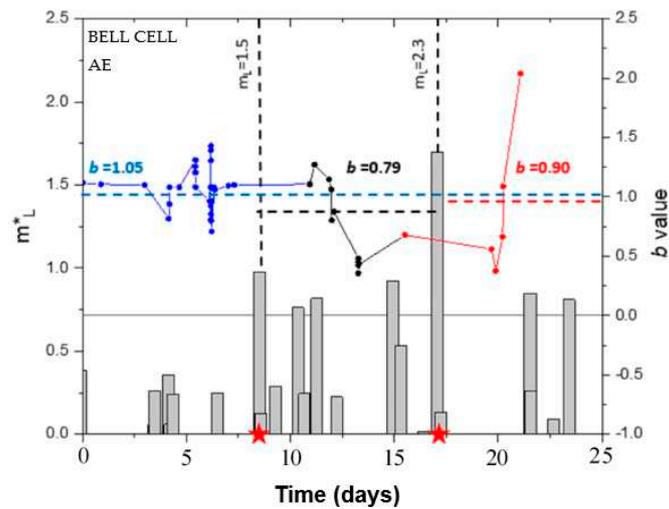
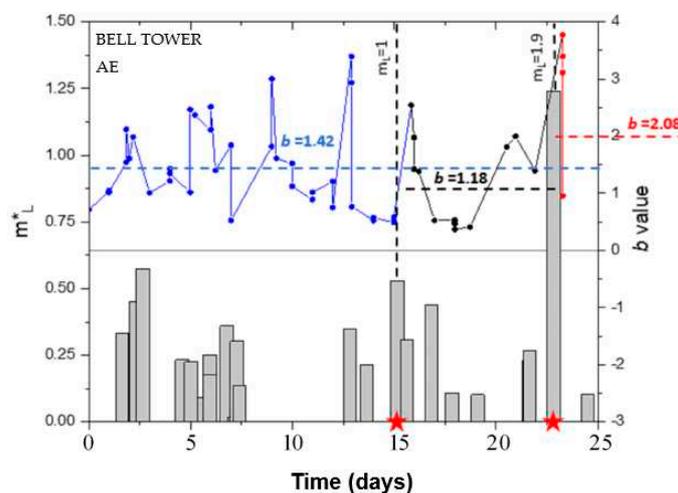
**Figure 13.** The seismic time series are represented together with the variations of the AE average  $b$ -values detected on the structures of the tower: (a,b)  $b$ -value time series considering the seismic activity along 40-day time windows. In both the two cases the average  $b$ -values demonstrated an evident reduction in correspondence of foreshocks periods between the anticipating and the main event. (c,d) At the same time, the  $b$ -value time series have been computed for AE data and correlated to the seismic activity for a period of 25 days contained in the previous larger time intervals.

where  $m_L^*$  is the reduced local magnitude;  $m_L$  is the actual local magnitude and  $d$  is the distance, measured in km, between the epicenter and the Bell Tower of the Turin Cathedral. In Figure 13 the two seismic time series were represented together with the variations of the average  $b$ -values.

These variations trends resulted particularly evident for both the two considered periods (10 May 2018–30 June 2018 and 1 August 2019–25 September 2019). For each period, two couples of events were recognized, each of them formed by one anticipant and one main event (the anticipant and the main events are distinguished by stars on the  $x$ -axis of the graph). The average values of the  $b$ -value before the anticipating events are 1.34 and 2.01 for the two periods, respectively (see Figure 13a,b). The reduced local magnitudes for the two anticipants are  $m_L^* = 1.5$  (1 June 2018, Inverso Pinasca, 44°57' N 7°13' E, near Turin); and  $m_L^* = 1.0$  (24 August 2019, Torre Pellice, 44°49' N 7°14' E). After these two events two phases, the first of about seven days and the second of about eight days with average  $b$ -values of 0.58 and 1.85 were observed for the two time windows. After these intervals, the expected seismic main events  $m_L^* = 2.3$  and  $m_L^* = 1.9$  took place (Figure 13a,b). These two events were both anticipated by the previously mentioned series where the average  $b$ -values encountered reductions of 56% and 8%. After the occurrence of the two events recognized as main events, the  $b$ -values trends returned to grow significantly—the average  $b$ -values were 1.22 for the first time window

and even 2.82 for the second (Figure 13a,b). The evidence here reported is useful to understand that the discrimination criterion reported by Guglia and Weimer (2019) [21] can be applied to seismic series with reduced magnitude values ( $0.5 < m_L < 3$ ) and also in the case of rescaled values that follow the reduction rule reported in Equation (8).
