FACTA UNIVERSITATIS
Series: **Mechanics, Automatic Control and Robotics** Vol.3, N° 13, 2003, pp. 755 - 764

DAMAGE DIAGNOSTIC IN CONCRETE AND MASONRY STRUCTURES BY ACOUSTIC EMISSION TECHNIQUE

A. Carpinteri, G. Lacidogna

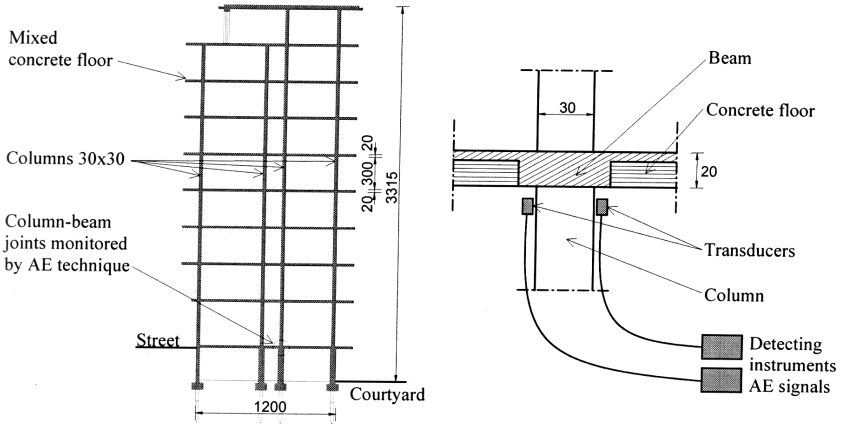
The AE methodology has been applied to two buildings, with reinforced concrete structure. The first building, built in the city of Moncalieri (Torino), around 1960, is located in the proximity of a bridge with high traffic density. It showed the formation of a network of microcracks in the internal walls (both within the apartments and around the stairs), and the occurrence of wide cracks on the external walls. Not significant crack has been detected in the concrete foundations nor on the concrete structure. Indeed, vibrations due to the heavy traffic are felt in the apartments at the top floors. In order to assess the stability of the structure, two column-beam joints located in the central part of the building, at the lower floor, have been monitored (Fig. 2).

Fig. 2. Building in Moncalieri. Structural section of the building and location of transducers on column-beam joints

The AE analysis permits to assert that the structural behaviour is stable, since the AE activity was practically absent during normal situatins (implying that no energy was released under service loads, i.e. damage was not propagating). In this specific case, the absence of AE activity shows that the traffic vibrations, although perceptible in the building, are efficiently absorbed by the structure damping capacity and do not result in cracking phenomena. On the other hand, the crack networks revealed on the vertical walls of the building can be ascribed to significant deformability and creep of the concrete floors.

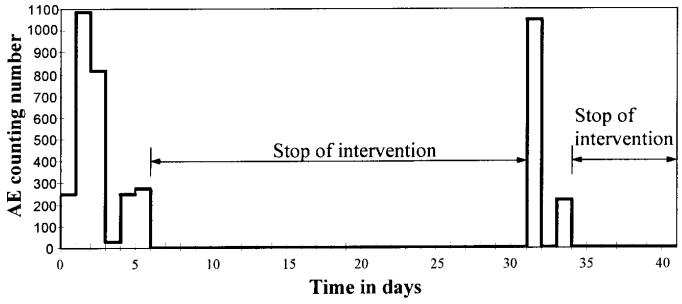
The structure has been continuously monitored for 40 days, corresponding to 960 hours. During this period of time, a rehabilitation activity was carried out on the roof and on the facade of the building. The oscillation count registered at the end of each day is plotted in Fig. 3. Notice that Acoustic Emission have not been revelaed during the stops of the intervention, whereas transducers perceived significant signals during the working days.

Fig. 3. Column-beam joint. AE counting number per each day of detection

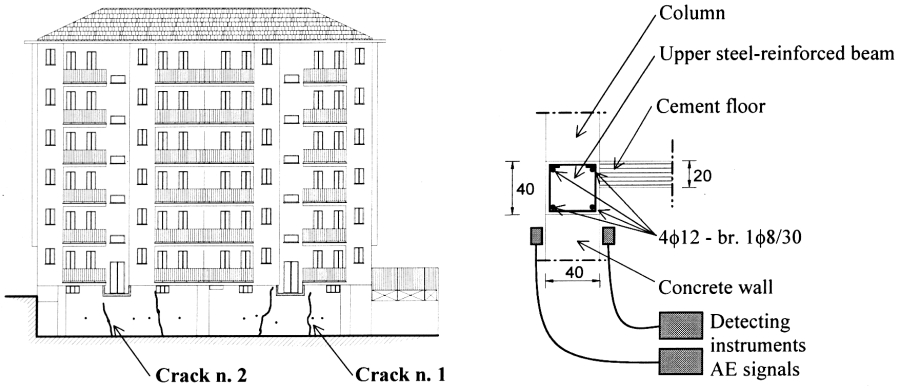
The second building that has been monitored is located in Cascine Vica (Torino). In this case, four important macro-cracks have appeared on a retaining wall made of not reinforced concrete situated at the bottom of the structure. Cracks started from the foundations of the wall, and propagated vertically, extending throughout the width, stopping only before a steel-reinforced beam put just below the concrete colums, see Fig. 4. The average crack opening was equal to 2 mm at the bottom and to almost 0.2 mm at the top of the wall.

Fig. 4. Building in Cascine Vica. Cracking framework and location of transducers on the concrete wall

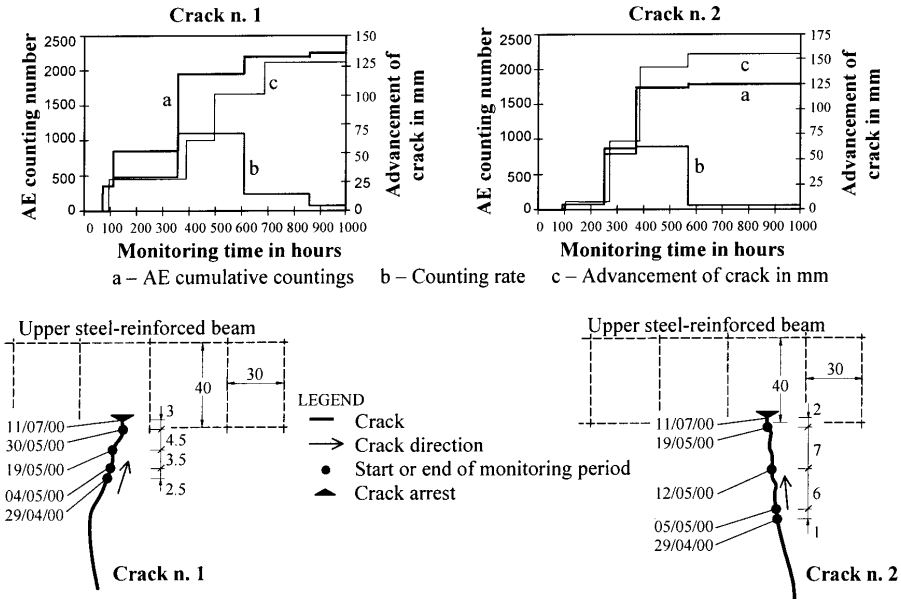
Fig. 5. Results of monitoring with the AE technique

We have chosen to monitor two main cracks which had not already reached the upper beam. We have tried to evaluate the speed of propagation of these cracks and to predict their future development based on the cumulative count of AE. The advancement has been monitored, in the case of both cracks, for almost 1000 hours, starting on April 29, 2000, an ending on July 11, 2000. In Fig. 5 the cumulative counts of emissions and the advancement of the cracks are reported and compared. Notice that, at any stage of the test, the oscillation count is proportional to crack propagation and that a reduction of AE density is directly related to crack arrest in the proximity of the upper beam (where a significantly larger toughness is attained due to steel reinforcement). Since the highest num-

ber of AE counts detected during the test corresponds to the maximum velocity of propagation, we can deduce that the local maxima of the AE distribution function correspond to the most critical stages of propagation.

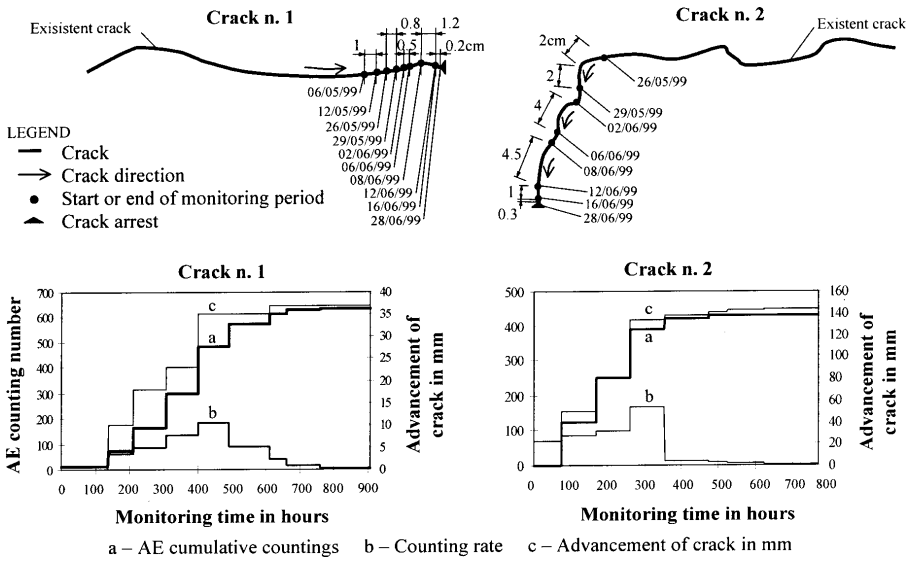
Two transducers have been used to detect the AE released by the cracks. They were applied approximately 3 cm far from the top of fissures, to minimise signal attenuation. The dates of the first application of the transducers and their final removal are represented in Fig. 7. The graphs, obtained by the monitoring data, exhibit how the behaviour of the countings is proportional to the advancing of the cracks and whow as the exhaustion of the ring-down counting cleraly reveal the arrest of the cracks advancement.

Furthermore diagrams remark that the maximum conting of AE happens during the highest velocity of the fissure advancing process. Following this event, both the counting than the crack advancement tend to decrease rapidly, until complete cancellation. We can therefore assume how the peak data of distribution of AE does correspond to the most critical period of advancing of the crack, which then reaches a condition of stability, proceeeding towards more compressed zones of masonry. Diagrams relative to time-advancing of fissures show a stable behaviour, as well as the diagrams that relate the time to the cumulative counting of AE.

Fig. 7. Crack n. 1 and 2. Development and AE monitoring results

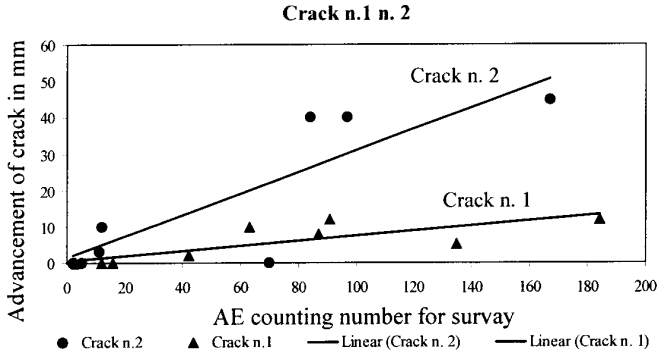
Correlation diagrams are represented in Fig. 8, independent of the time, between the crack advancement and the number of AE events. This graph puts synthetically in comparison the behavior of the two masonries during the cracking process. We indeed note how, the ectension being the same, crack n 2 released much less energy than crack n. 1, showing a higher toughness of the material where it developed. For crack n. 2, the correlation values between crack advancement and number of AE events are more distant from the average line than those referring to crack n. 1. The larger dispersion chows how the material crossed by crack n. 2 (the bricks masonry) is more heterogeneous and therefore tougher than the material crossed by crack n. 1 (the little wall in concrete).

Fig. 8. Diagrams of correlation between the number of AE events and the crack advancement

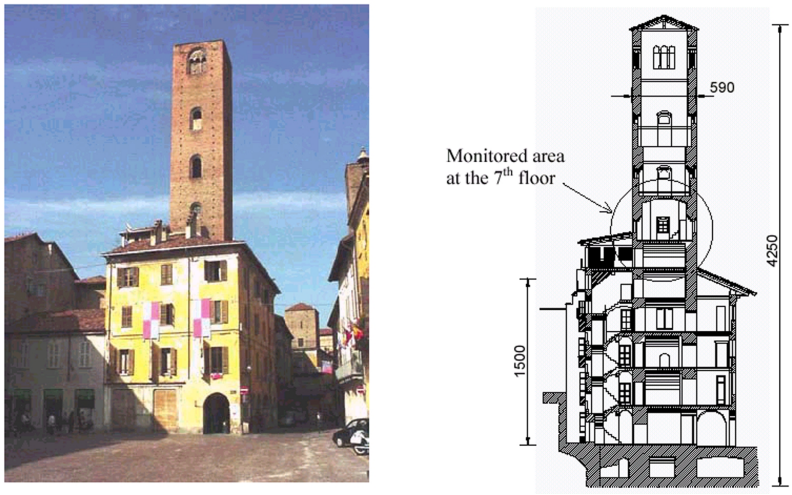
Fig. 9. Sineo Tower in Alba

The cracking framework can be observed both on the internal then external overview. The most significant crack are inside the tower, mainly located between the 6th and 8th floors. On the external side we can observed minor cracks, mainly near the windows, more specifically between the 6th and 7th floors.

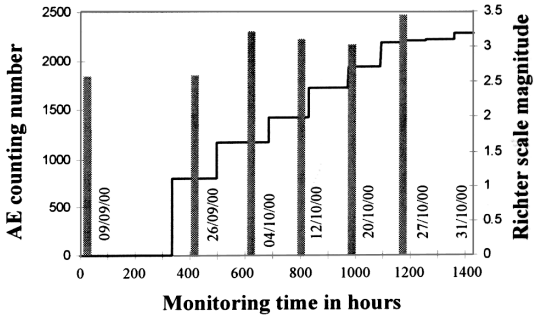
Through the monitoring of AE two cracks have been detected in the internal surface of masonry on the 7th floor, Fig. 10: one located by a window, and the other one nearly. The monitoring has reported a continuos damaging process, characterized by a slow spread of cracks inside the brick walls. In the most damaged zone, we detected and arrest of the damaging progress, since the cracks have arhieved a new condition of stability, leading towards compressed zones of masonry.

In this particular case it could be observe how each appreciable advancing of the cracks, in the monitoring zone, is often correlated by a seismic event. In the diagram of Fig. 10, we have overlaid the cumulative AE function, of the monitored area, with the seismic occurrences and their intensity, happened in Alba region in the same period of time. The seismic events data have been provided by the National Institute for Geophisics and Volcanology in Rome. This detection might prove how the tower behaves stable when is only subject to vertical loads. The structure, in fact, doesn't have the capacity to respond elastically when it is subject to horizontal or waving actions.

Fig. 10. Sineo Tower monitoring
