Engineering Fracture Mechanics

Damage monitoring of three-point bending concrete specimens by acoustic emission and resonant frequency analysis

Giuseppe Lacidogna, Gianfranco Piana*, Alberto Carpinteri

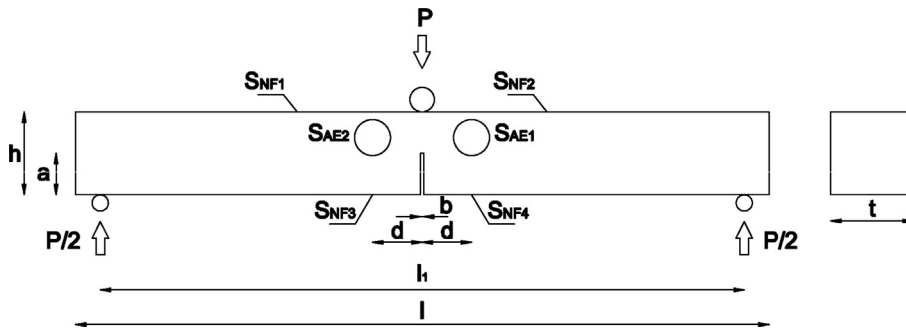
Fig. 1. Specimen geometry and loading configuration: S_{AE1} and S_{AE2} denote the broadband and resonant AE sensors, respectively; S_{NF1} – S_{NF4} denote the sensors used for the resonant frequency identification.

Tests were conducted on two concrete beam samples having length $l = 84$ cm and square cross-section of side 10 cm. The samples were pre-notched at mid-length for half of the depth (notch width equal to 4 mm). The specimens geometry and the loading configuration are shown in Fig. 1, while the geometric dimensions are listed in Table 1. Specimens features and experimental set-up were defined according to RILEM TC 50-FMC protocol [29]. Values of mass density $\rho = 2310$ kg/m³ and compression strength $R_c = 26.4$ MPa were obtained averaging measures made on five concrete cubic specimens of side 16 cm.

Table 1
Geometric dimensions of the specimen in Fig. 1 (in mm).

l	h	t	a	b	l_1	d
840	100	100	50	4	780	60

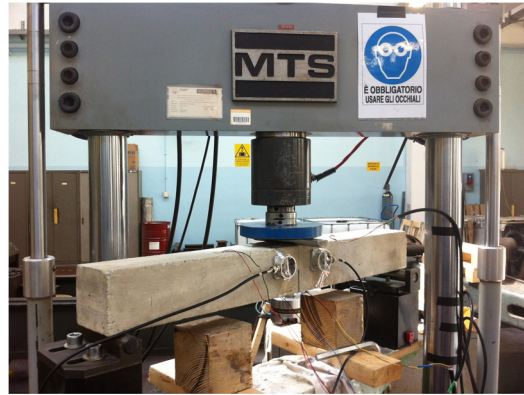
Fig. 2. Experimental set-up of the three-point bending tests conducted.

The specimens were tested, up to final failure, on a servo-hydraulic MTS machine by controlling the vertical displacement of the hydraulic jack. The specimens were equipped with four JPR Plustone 400-403 piezoelectric pickups (outer diameter 20 mm, frequency range ~ 0 –20 kHz, resonant frequency 6 ± 0.5 kHz, operating temperature -20 to $+50$ °C, weight ~ 1 g) for the extraction of resonant frequencies [30] and two piezoelectric AE detectors (by LeaneNet S.r.l., Sarzana, Italy), one of broadband (S_{AE1}) and one of resonant (S_{AE2}) type (frequency range of $S_{AE1} = 80$ –400 kHz; resonant frequency of $S_{AE2} = 160$ kHz; cylindrical aluminum case dimensions: diameter 50 mm, thickness 35 mm; weight 110 g). Broadband sensors have wider operating frequency range and lower sensitivity than resonant sensors. The latter are to be preferred when monitoring elements of heterogeneous materials or large structures, as well as if accurate damage localization is required. In this study, despite AE data of both the two sensors applied were acquired, only those captured by the resonant sensor S_{AE2} were analyzed. The pickups were coupled to an 8-channel Audiobox 1818VS1 acquisition device (by PreSonus; Baton Rouge, LA, USA); the sampling frequency was set to 48 kHz. The AE sensors were connected to an 8-channel National Instruments digitizer; the acquisition threshold was set equal to 5 mV and the sampling frequency equal to 1 MHz. Fig. 2 shows the experimental set-up of the three-point bending tests conducted. As regards the number of sensors used, we must say that, in fact, 4 pickups are redundant for the extraction of resonant frequencies, for which one sensor is, in line of principle, sufficient. By contrast, a larger number of AE sensors is required for source localization [31,32]. However, AE signal localization was not an objective of the present work.

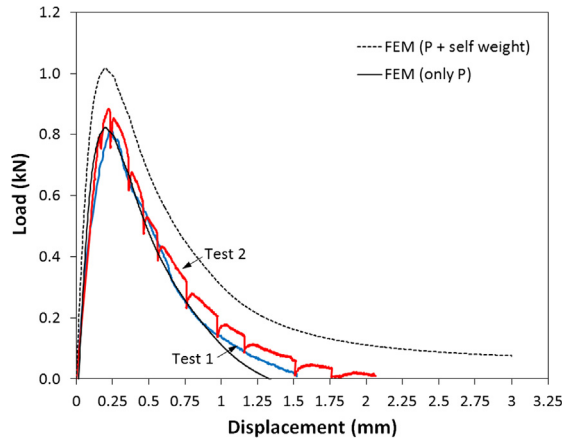
Fig. 9. Numerical (FEM) vs. experimental (tests 1 and 2) load–deflection curves.

Numerical finite element models of the beam were implemented in LUSAS by using plane stress elements. A first model was built using three-node triangular elements (TPM3) and adopting a nonlinear constitutive relation, both in tension and compression, for concrete. For the latter, the so-called Smoothed Multi Crack Model (Model 102) was used with the following mechanical parameters: uniaxial (cylindrical) compressive strength $f_c = 21.9$ MPa; uniaxial tensile strength $f_t = 2.4$ MPa; fracture energy $G_F = 184$ J/m². The values of f_c and f_t were evaluated, according to Eurocode 2 [38], starting from the measured value of R_c reported in Section 2.1; the value of G_F was evaluated experimentally according to RILEM TC 50-FMC protocol [29]. The triangular shape of the plane stress finite elements was selected to model the crack formation and propagation easily. A nonlinear static analysis was run on this model to obtain the load vs. deflection curve. The result is shown in Fig. 9, where the numerical curves are superimposed to the experimental ones: the dashed black line refers to the total acting load (mid-span force P plus the beam self weight), while the continuous black line refers to the mid-span force P only, as is for the experimental curves. As can easily be seen, the numerical curve reproduces pretty well

the experimental trends.
